Storm Damage Report

Memorial Inn & Suites
9535 Katy Freeway
Houston, Texas 77024

FIELD REPORT FOR INITIAL STORM DAMAGE INVESTIGATION

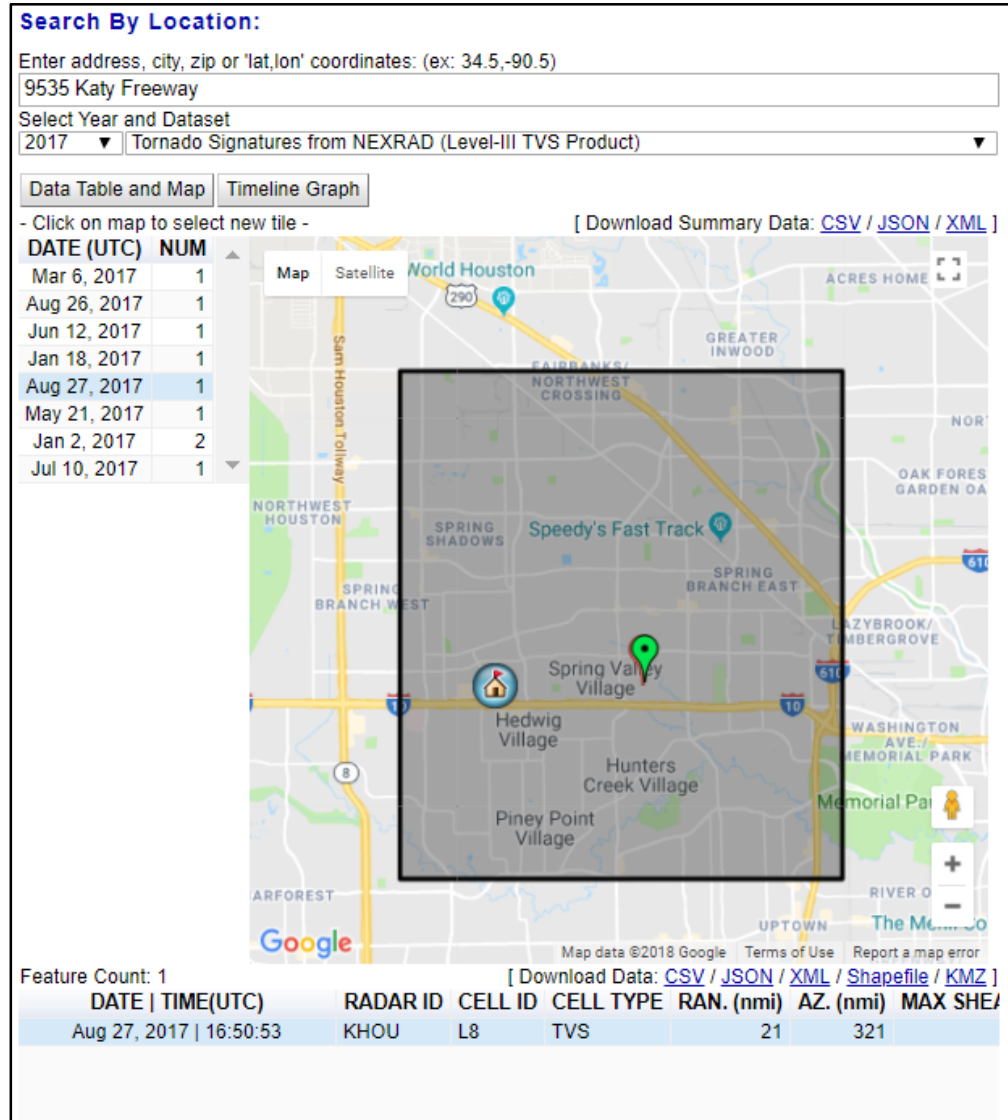
A tornado signature was reported by NEXRAD 2 miles east of the site.

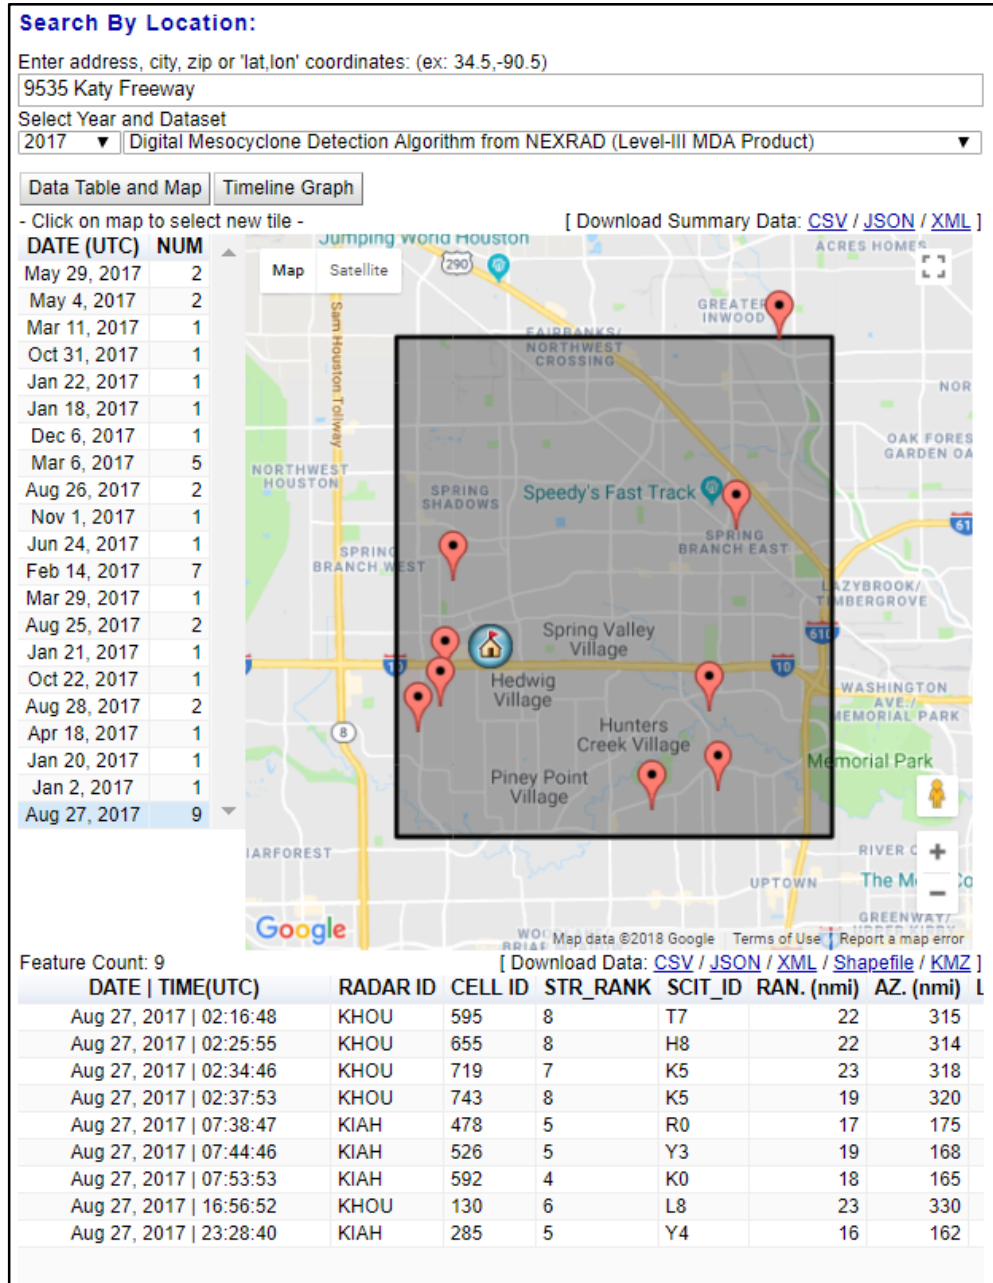
Nine digital mesocyclone events were recorded in the area with one occurring 1/2 mile west of the site.

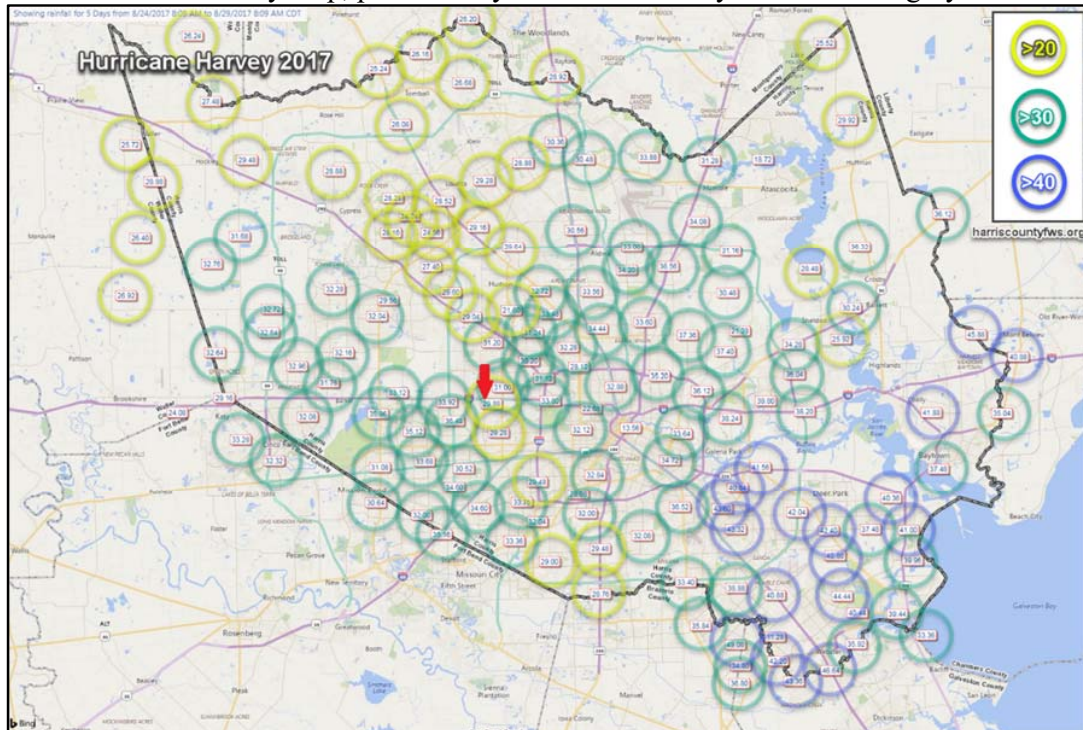
Red arrow is placed at location of the Memorial Inn. Map indicates approximately 30" of rain fell in the vicinity between August 24 and 29, 2017.

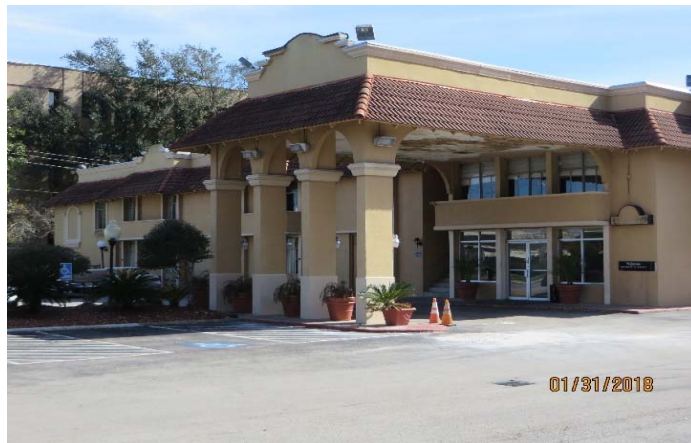
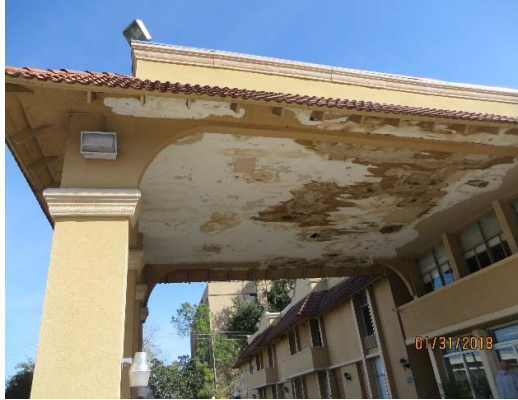
Figure 1

- The ceiling of the porte-cochere was water damaged and the finish was removed for safety reasons.
- Many of the window air-conditioning units had damage to the plastic fins. Some were said to be broken as a result of the storm, while others were broken from unrelated causes.

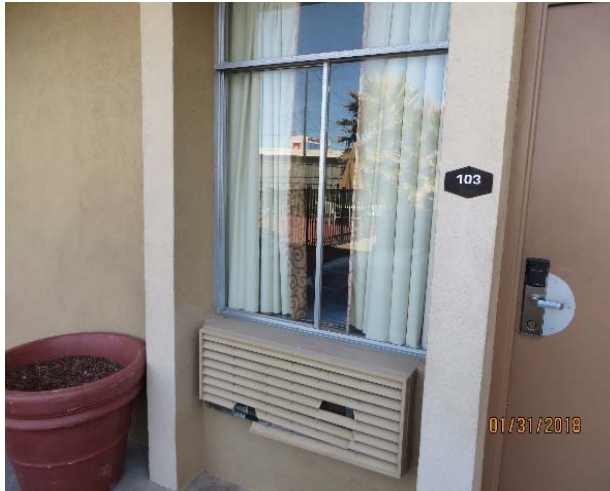
Figure 2

- Several windows were broken from wind or wind-borne debris. Units with broken windows include 104, 114, 116, 117, 124, 166, 171, 177, 184, 209, 257, 261, and 262.
- Some windows have been replaced and others have been removed, but not yet replaced.
- Gaps identified around window frames were new in appearance and were consistent with wind damage. These gaps should be considered storm created openings.

In our opinion additional windows have been damaged by wind and require replacement. In our opinion, parging at the base of the structure was water damaged requiring removal and replacement. In our opinion, the scope of repairs allowed for by the carrier was deficient.

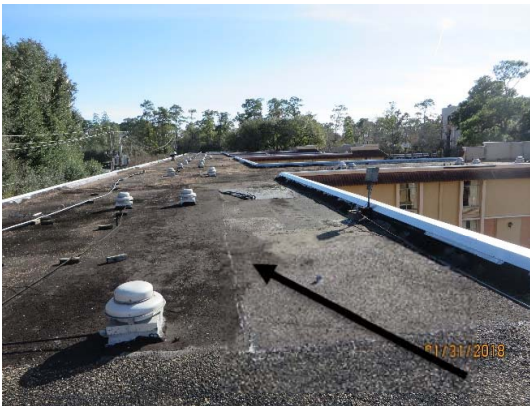
Figure 5

- Scour and cap sheet separation and debonding was observed on the BUR.[See Figure 5]
- Decorative 6- foot high wood-framed parapets were installed on top of the roof above the functional parapets along the north elevation and the west ends of each wing. The interior side of these parapets were clad with plywood. The top of these parapets were clad with exterior insulation and finish system (EIFS) which was capped with metal. During our inspection, a crew was replacing plywood that had been dislodged during the storm event. In general the plywood was in poor condition.

In our opinion, removal of the roof system to the concrete deck, drying out of the deck and installation of new above deck insulation with a new roof covering will be required as a result of damage from the storm event. Parapet walls will require replacement. New roof system will not allow for any gravel ballast.

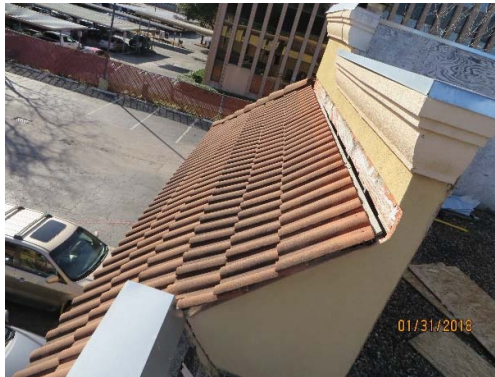
Figure 6

- 2" x 4" non-conventional wood bracing used for tall parapets.

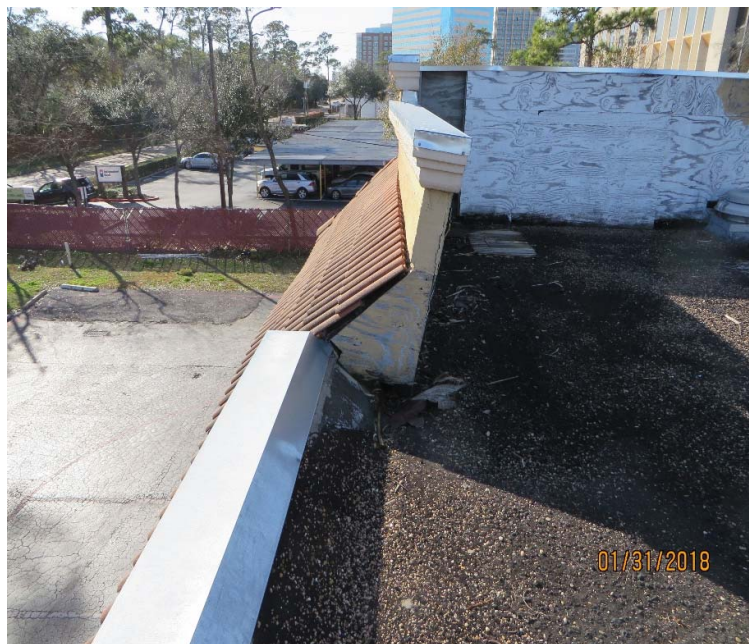
Figure 8 Parpet pushed inward

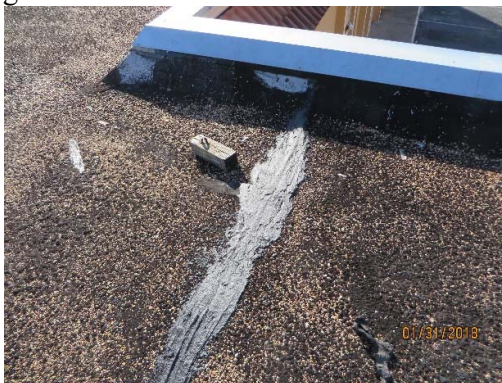
Figure 9

- Expansion joints running east-west observed between wing sections, with temporary patching done on sections.

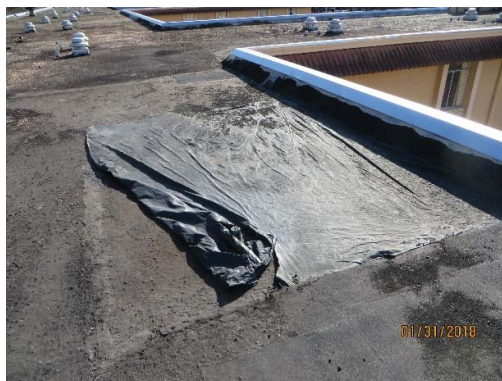
Figure 10

- Roof areas where an additional flood coat was applied
- A temporary repair with a black tarp observed between the first and second wings.

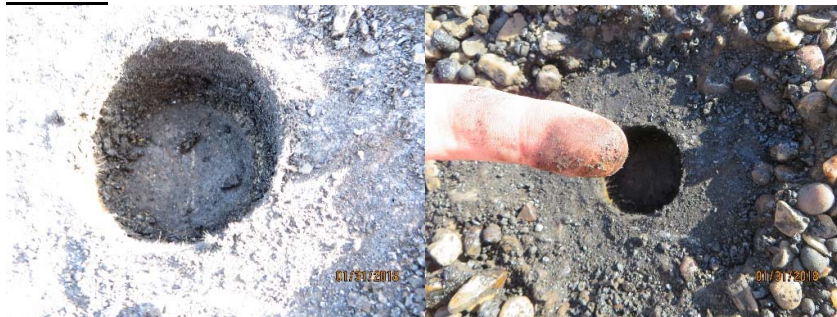
Core #1

- Located on the 1st (northernmost) wing, 13' from South wall, 50' from East wall
- Gravel Ballast

- ½" 3-ply BUR
- ½" fiberglass insulation
- Concrete deck
- All materials were wet

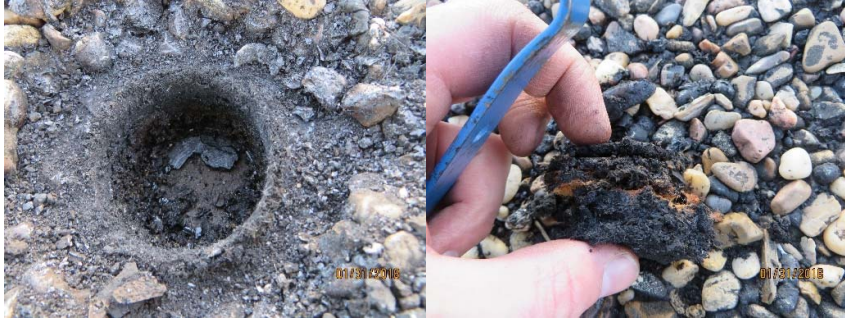
Core #2

- Located on the 3rd (middle) wing, 8' from North wall, 32' from West wall
- Gravel Ballast
- ½" 3-ply BUR
- ½" fiberglass insulation
- Concrete deck
- All materials were wet

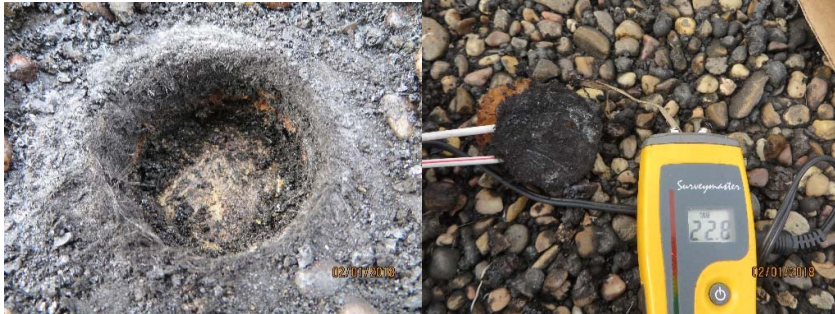
Core #3

- Located on the 5th (southernmost) wing, 7' from South wall, 8' from West wall
- Gravel Ballast
- ½" 3-ply BUR
- ½" fiberglass insulation
- Concrete deck
- All materials were wet

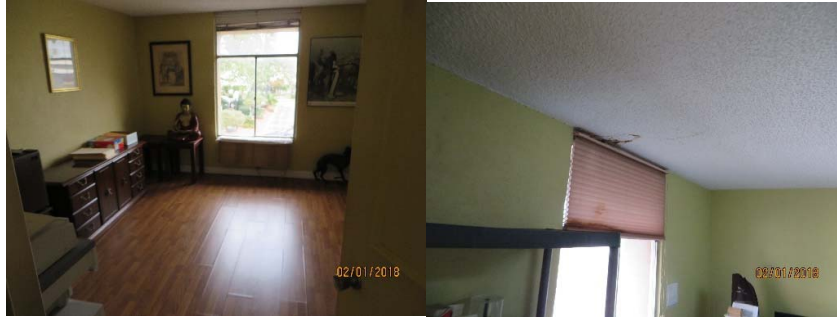
Figure 11

- Water damage to laminate floor
- Water damage to ceiling
- Water damage to window shade
- Water damage to wall
- Water damage to baseboard

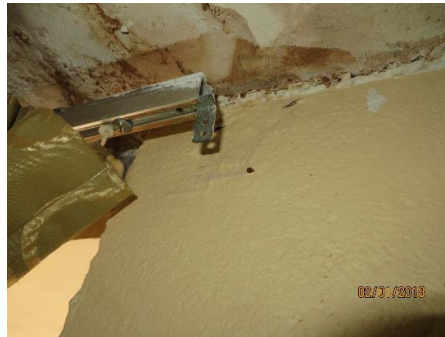
Figure 12

- Water damage to ceiling
- Water damage to wall

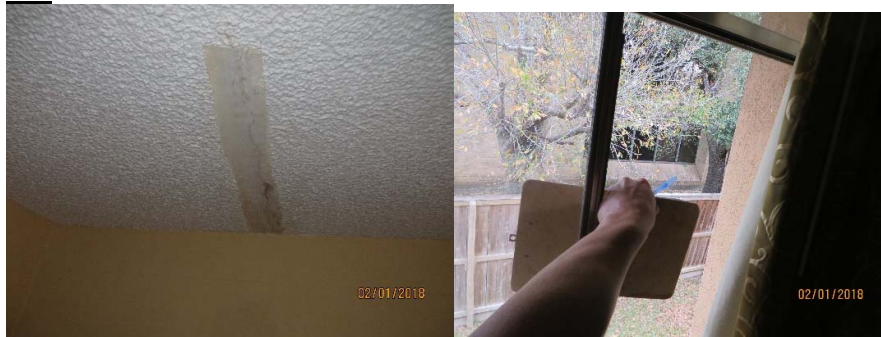
Figures 13 and 13A

- Water damage to ceiling
- Water damage to wall
- Window missing

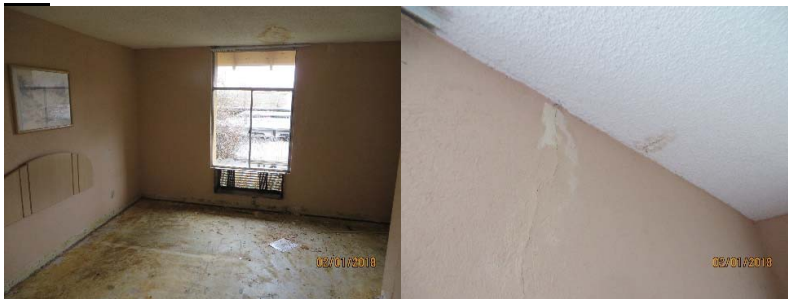
Figures 14 and 14A

- Water damage to ceiling
- Water damage to wall
- Water damage to carpet
- A/C unit missing

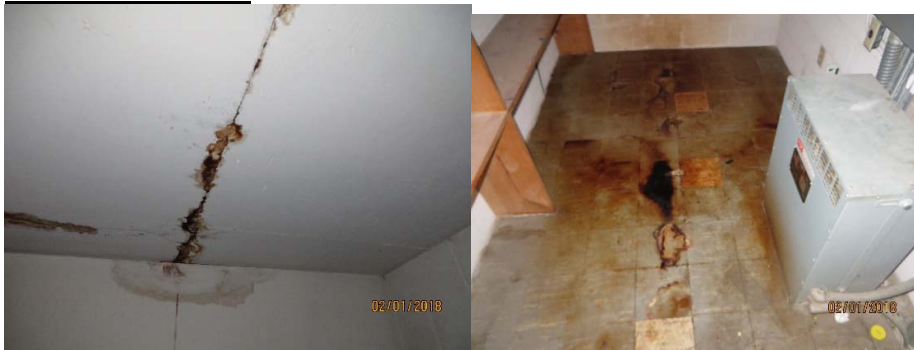
Figures 15 and 15A

- Water damage to ceiling
- Water damage to wall
- Water damage to floor

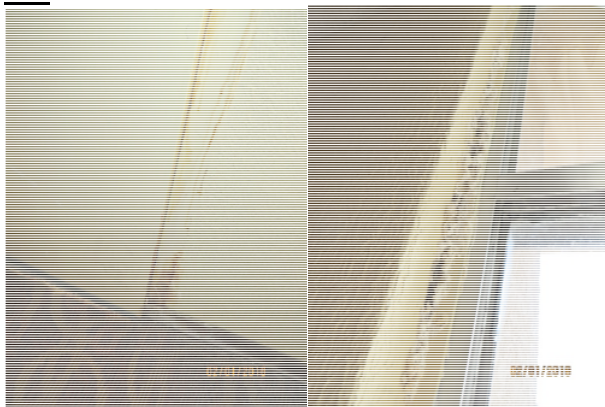
Figures 16 and 16A

- Water damage to wall

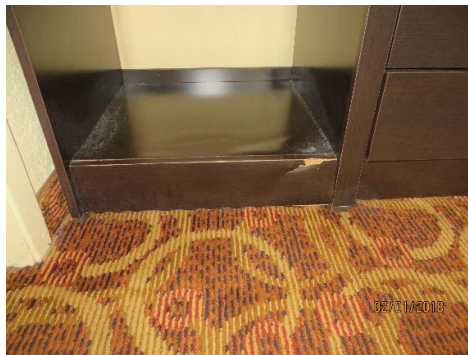
Figure 17

- Water damage to carpet
- Water damage observed on wood dresser

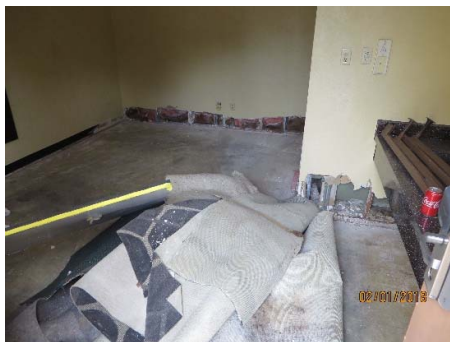
Figure 18

- Water damage to carpet
- Water damage to base of wall

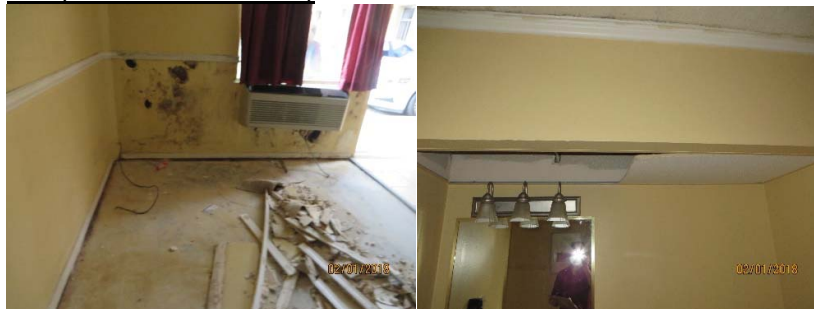
Figures 19 and 19A

- Water damage to carpet
- Water damage to wall
- Water damage to ceiling
